North Providence Schools Facility Study

Stage I

January 16, 2014

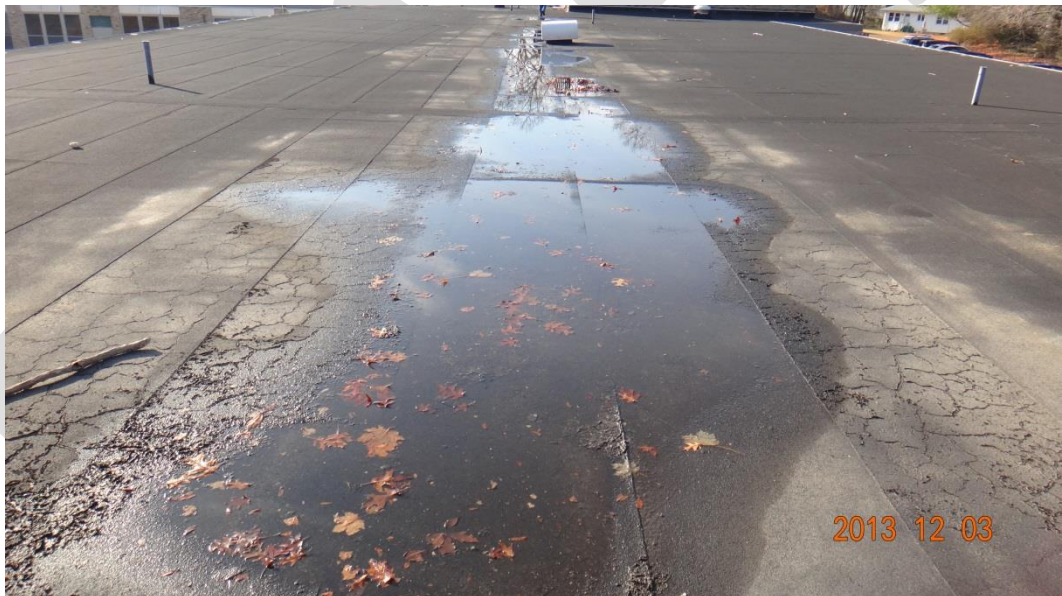
PHOTO #2 – This photograph shows the water ponding on the roof of the northeast wing of the building.

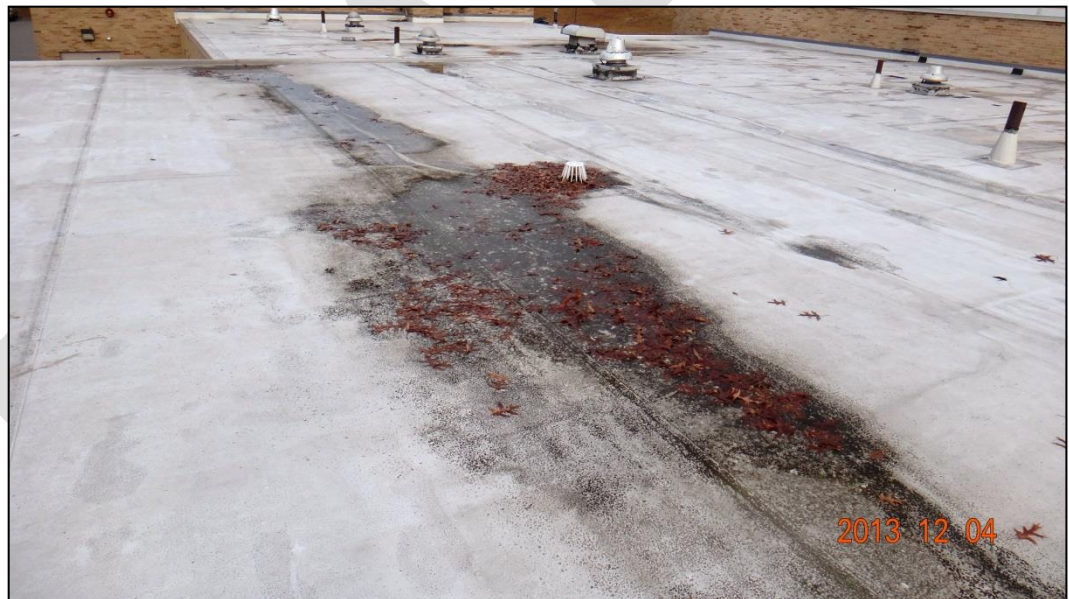
PHOTO #2 – *This photograph shows another of the locations where water is ponding on the roof of the school building.*

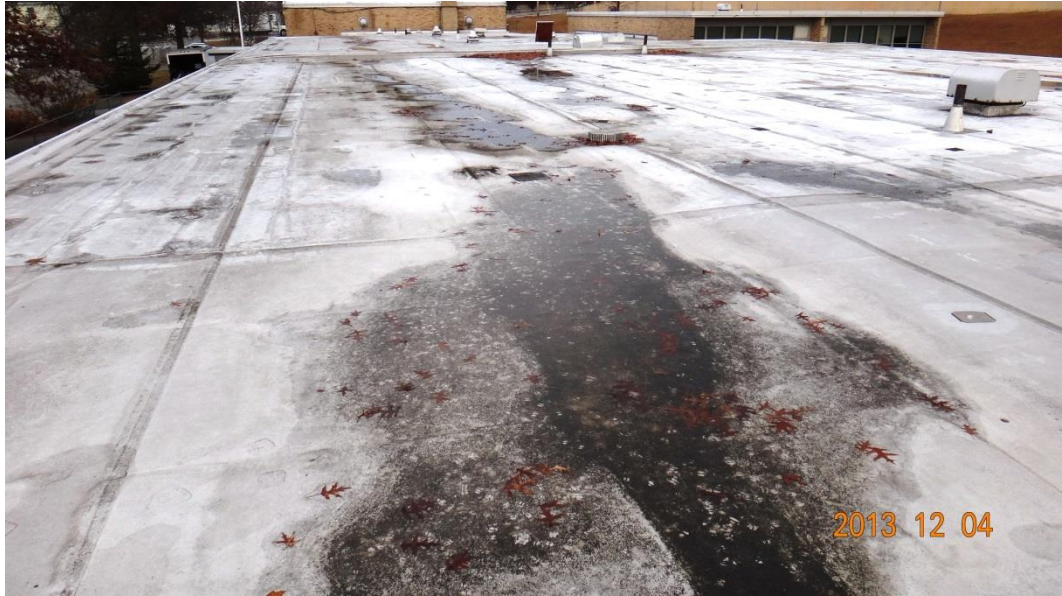
PHOTO #3 – *This photograph shows another location where water is ponding on the roof of the school building.*

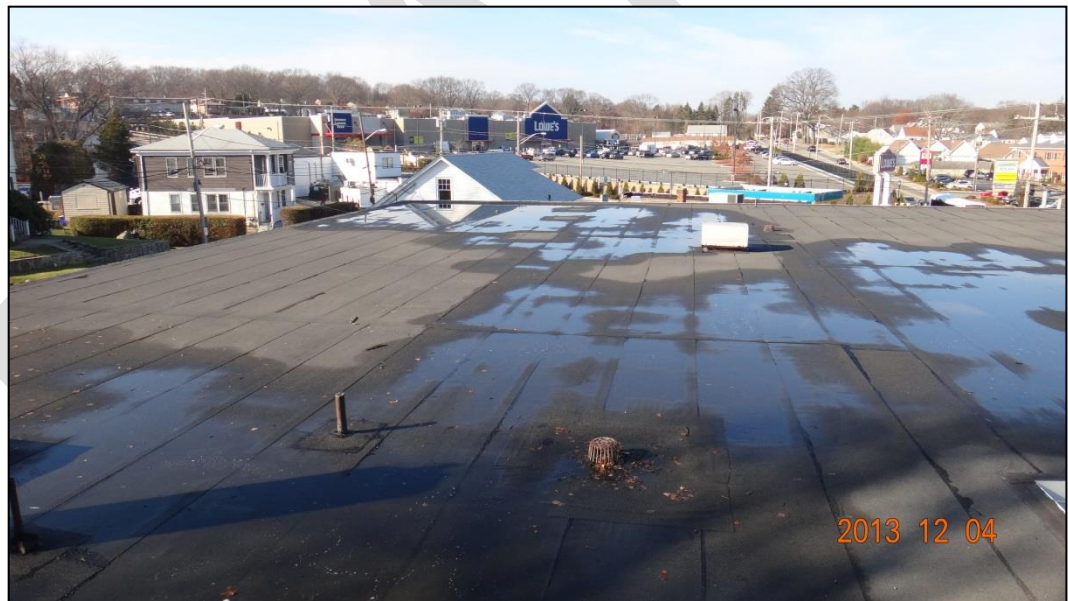
PHOTO #2 – *This photograph shows more ponding of water on the northwest wing flat roof.*

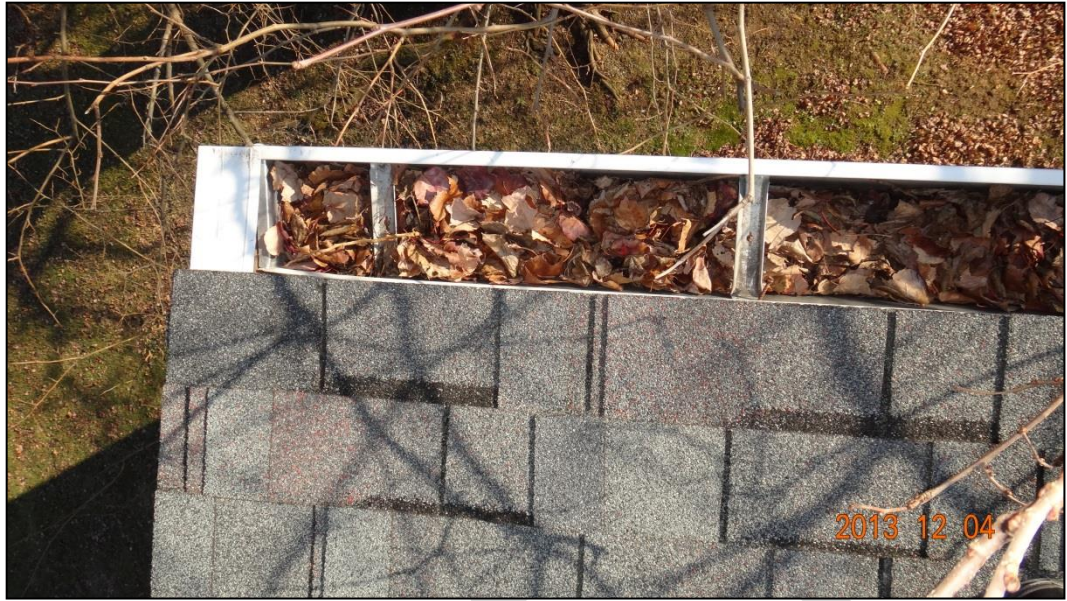
2. The gutters on the sloped roof of the Stephen Olney Elementary School Gymnasium/Cafeteria building are clogged with debris. (Please refer to the Photos #4 and #5 below.) **Comments and Recommendations:** *The roof gutters must be cleaned of debris on a regular basis to protect the roofing system and building.*

PHOTO #5 – *This photograph shows the leaves clogging the gutter on the sloped roof of the Stephen Olney Elementary School Gymnasium/Cafeteria building*
